Contract #: 04-0120F4Cty: SF/ALA Rte: 80 PM: 13.2/13.9File #: 69.28**WELDING INSPECTION REPORT****Resident Engineer:**Pursell, Gary**Address:** 333 Burma Road**City:** Oakland, CA 94607**Report No:** WIR-008490**Date Inspected:** 15-Aug-2009**Project Name:** SAS Superstructure**OSM Arrival Time:** 1845**Prime Contractor:** American Bridge/Fluor Enterprises, a JV**OSM Departure Time:** 715**Contractor:** Zhenhua Port Machinery Company, Ltd (ZPMC), Changxing Island **Location:** Shanghai, China**CWI Name:** See Below**CWI Present:** Yes No**Inspected CWI report:** Yes No N/A**Rod Oven in Use:** Yes No N/A**Electrode to specification:** Yes No N/A**Weld Procedures Followed:** Yes No N/A**Qualified Welders:** Yes No N/A**Verified Joint Fit-up:** Yes No N/A**Approved Drawings:** Yes No N/A**Approved WPS:** Yes No N/A**Delayed / Cancelled:** Yes No N/A**Bridge No:** 34-0006**Component:** Tower Fabrication**Summary of Items Observed:**

On this date CALTRANS OSM Quality Assurance (QA) Inspector, Mr. Paul Dawson, arrived on site at the Zhenhua Port Machinery Company (ZPMC) facility at Changxing Island, in Shanghai, China, for the purpose of monitoring welding and fabrication of the San Fra

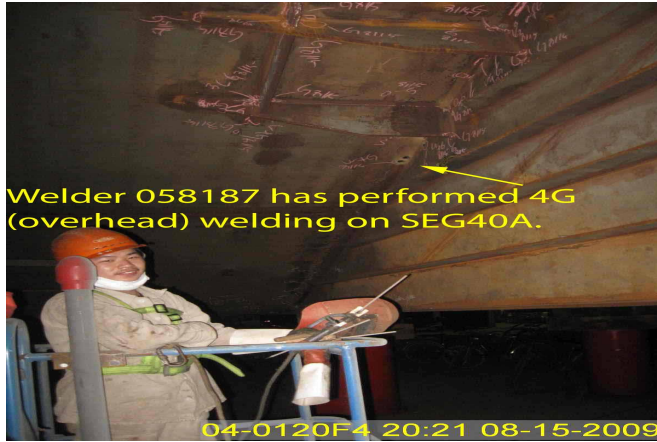
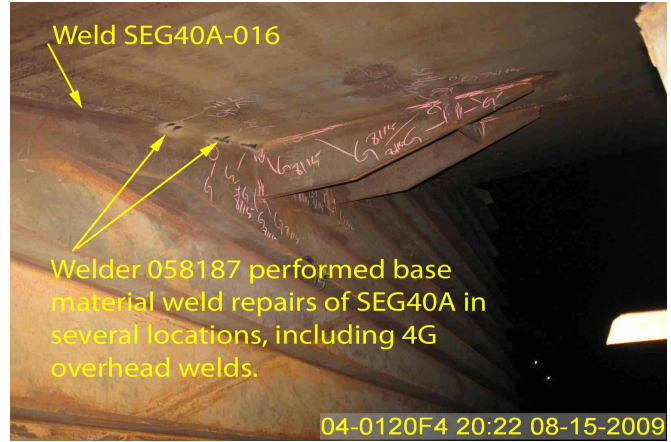
This QA Inspector observed ZPMC welder Mr. Chen Renzhi, stencil 058187 is performing shielded metal arc weld repairs to various locations on and near weld SEG40A-16 at panel point PP57, 7DE. This QA Inspector measured a welding current of approximately 160 amps. This QA Inspector observed Mr. Chen Renzhi is certified to perform welding in the 1G, 2G and 3G positions and some of the weld repairs performed by Mr. Chen Renzhi are in the 4G position. Mr. Chen Renzhi is not certified to perform 4G position welds and this QA Inspector issued an Incident Report to document this procedure violation. ABF representative Mr. Bao Qian informed this QA Inspector that ZPMC welder stencil 058187 has been performing these weld repairs on SEG40A without any ZPMC Quality Control (QC) CWI Inspection personnel being present to monitor this welding. This QA Inspector informed Mr. Bao Qian that this QA Inspector is issuing an Incident Report to document Mr. Chen Renzhi welding in the 4G position and based on this discussion the incident report will include ZPMC performing welding without any Quality Control Certified Welding Inspection personnel monitoring this welding. Items observed on this date do not appear to comply with applicable contract documents. See the photographs below for additional information.
